## Windstorm Mitigation Report

Fox Chase Townhomes Unit A Homeowners' Association, Inc.

Palm Harbor, FL

As of 03-20-2025 | FPAT File# MIT2524402

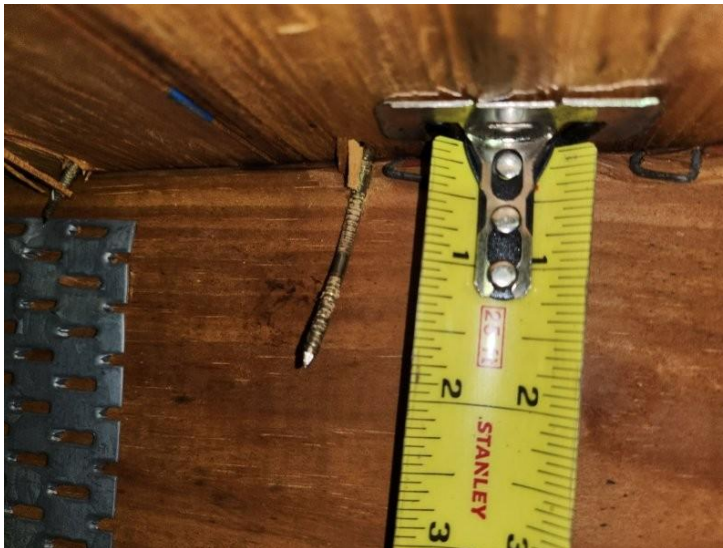
Roof Permit Information

- 2. Roof Covering:** **FBC Equivalent**  
Comments: The roof covering was replaced in 2019. The roof permit was confirmed and the permit number is PER-H-CB19-05255. This roof was verified as meeting the building code requirements outlined on the mitigation affidavit.

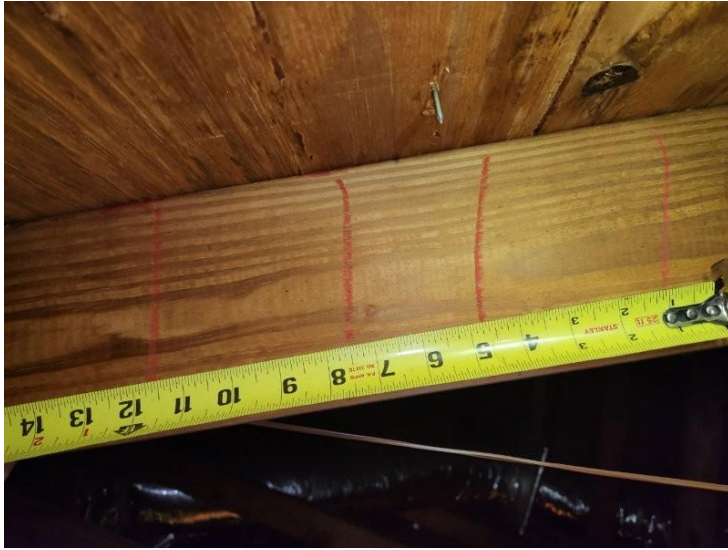
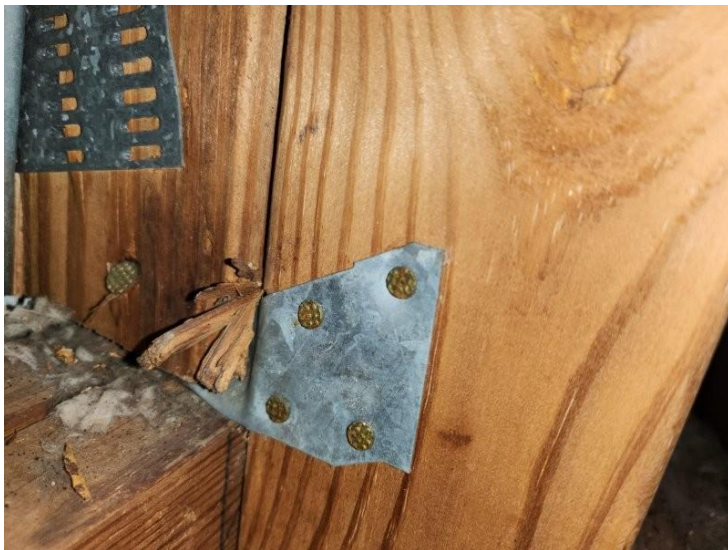
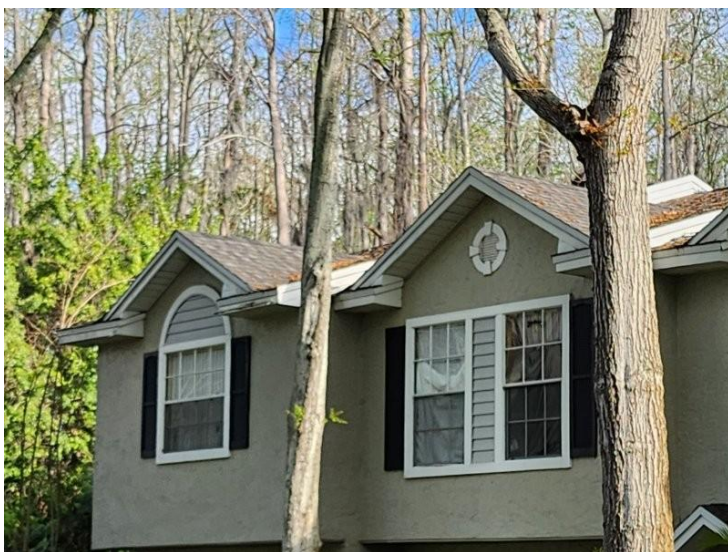
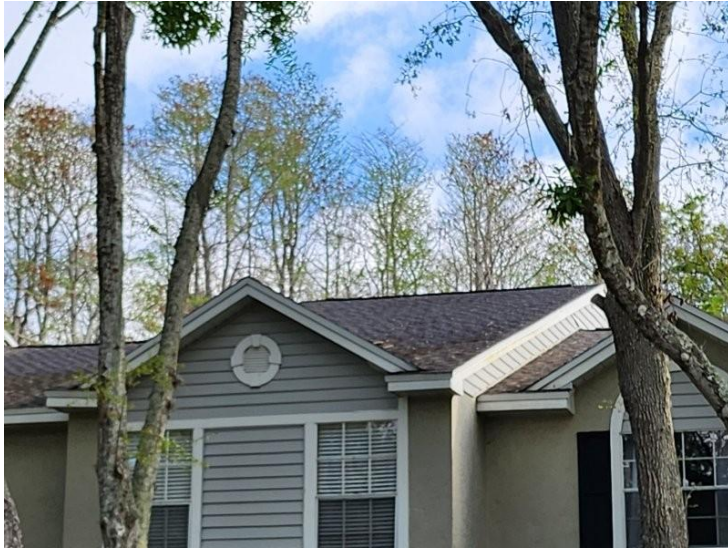
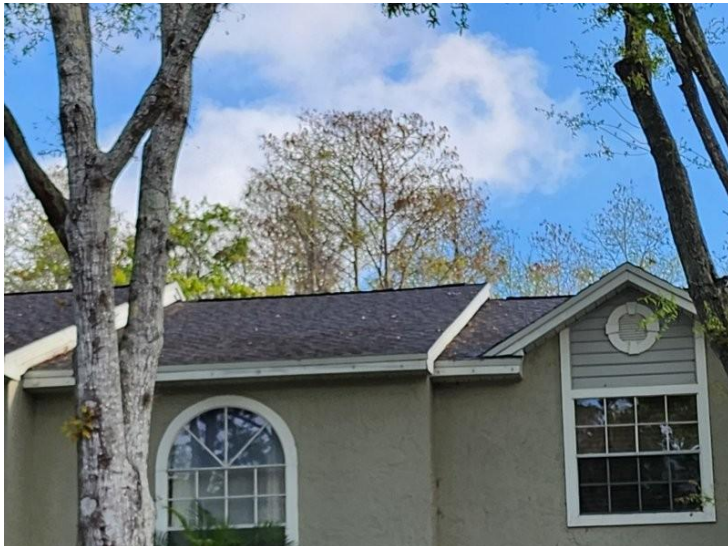
Roof Construction

- 3. Roof Deck Attachment:** **Level C**  
Comments: Inspection verified 1/2" plywood roof deck attached with 8d nails at a minimum 6" on the edge & 6" in the field.

- 4. Roof to Wall Attachment:** **Clips**  
Comments: Inspection verified hurricane clips fastened with a minimum of three nails.
- 5. Roof Geometry:** **Other Roof**  
Comments: Inspection verified a gable roof shape.

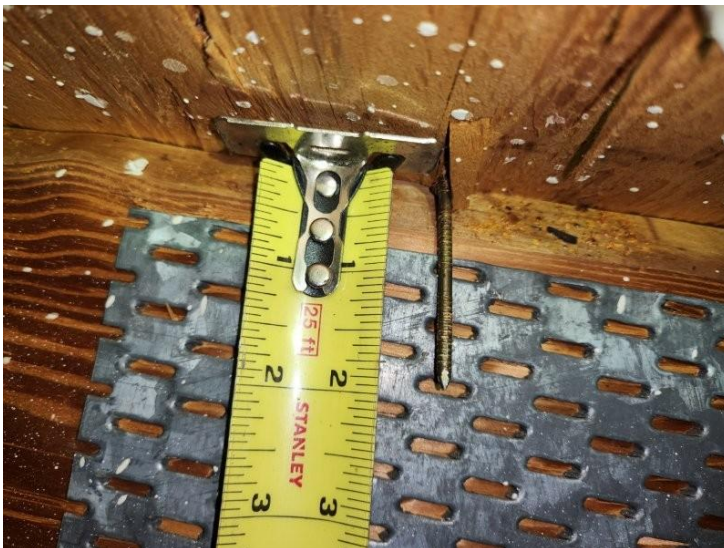
Roof Permit Information

- 2. Roof Covering:** **FBC Equivalent**  
Comments: The roof covering was replaced in 2019. The roof permit was confirmed and the permit number is PER-H-CB19-05256. This roof was verified as meeting the building code requirements outlined on the mitigation affidavit.

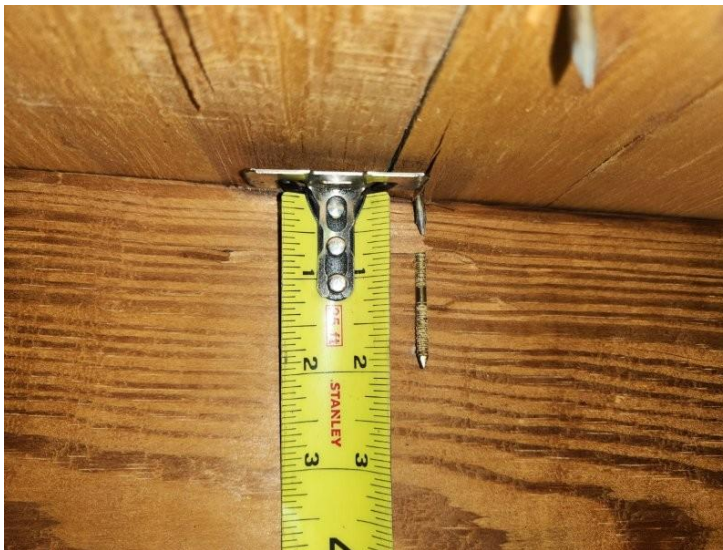
Roof Permit Information

- 2. Roof Covering:** **FBC Equivalent**  
Comments: The roof covering was replaced in 2019. The roof permit was confirmed and the permit number is PER-H-CB19-05252. This roof was verified as meeting the building code requirements outlined on the mitigation affidavit.
